DEVELOPMENT OF ULTRA-THIN FILM
PRESERVATIVE COMPOUNDS

Quarterly Report No. 3

1 February 1962 through 30 April 1962

FOSTER D. SNELL, INC.

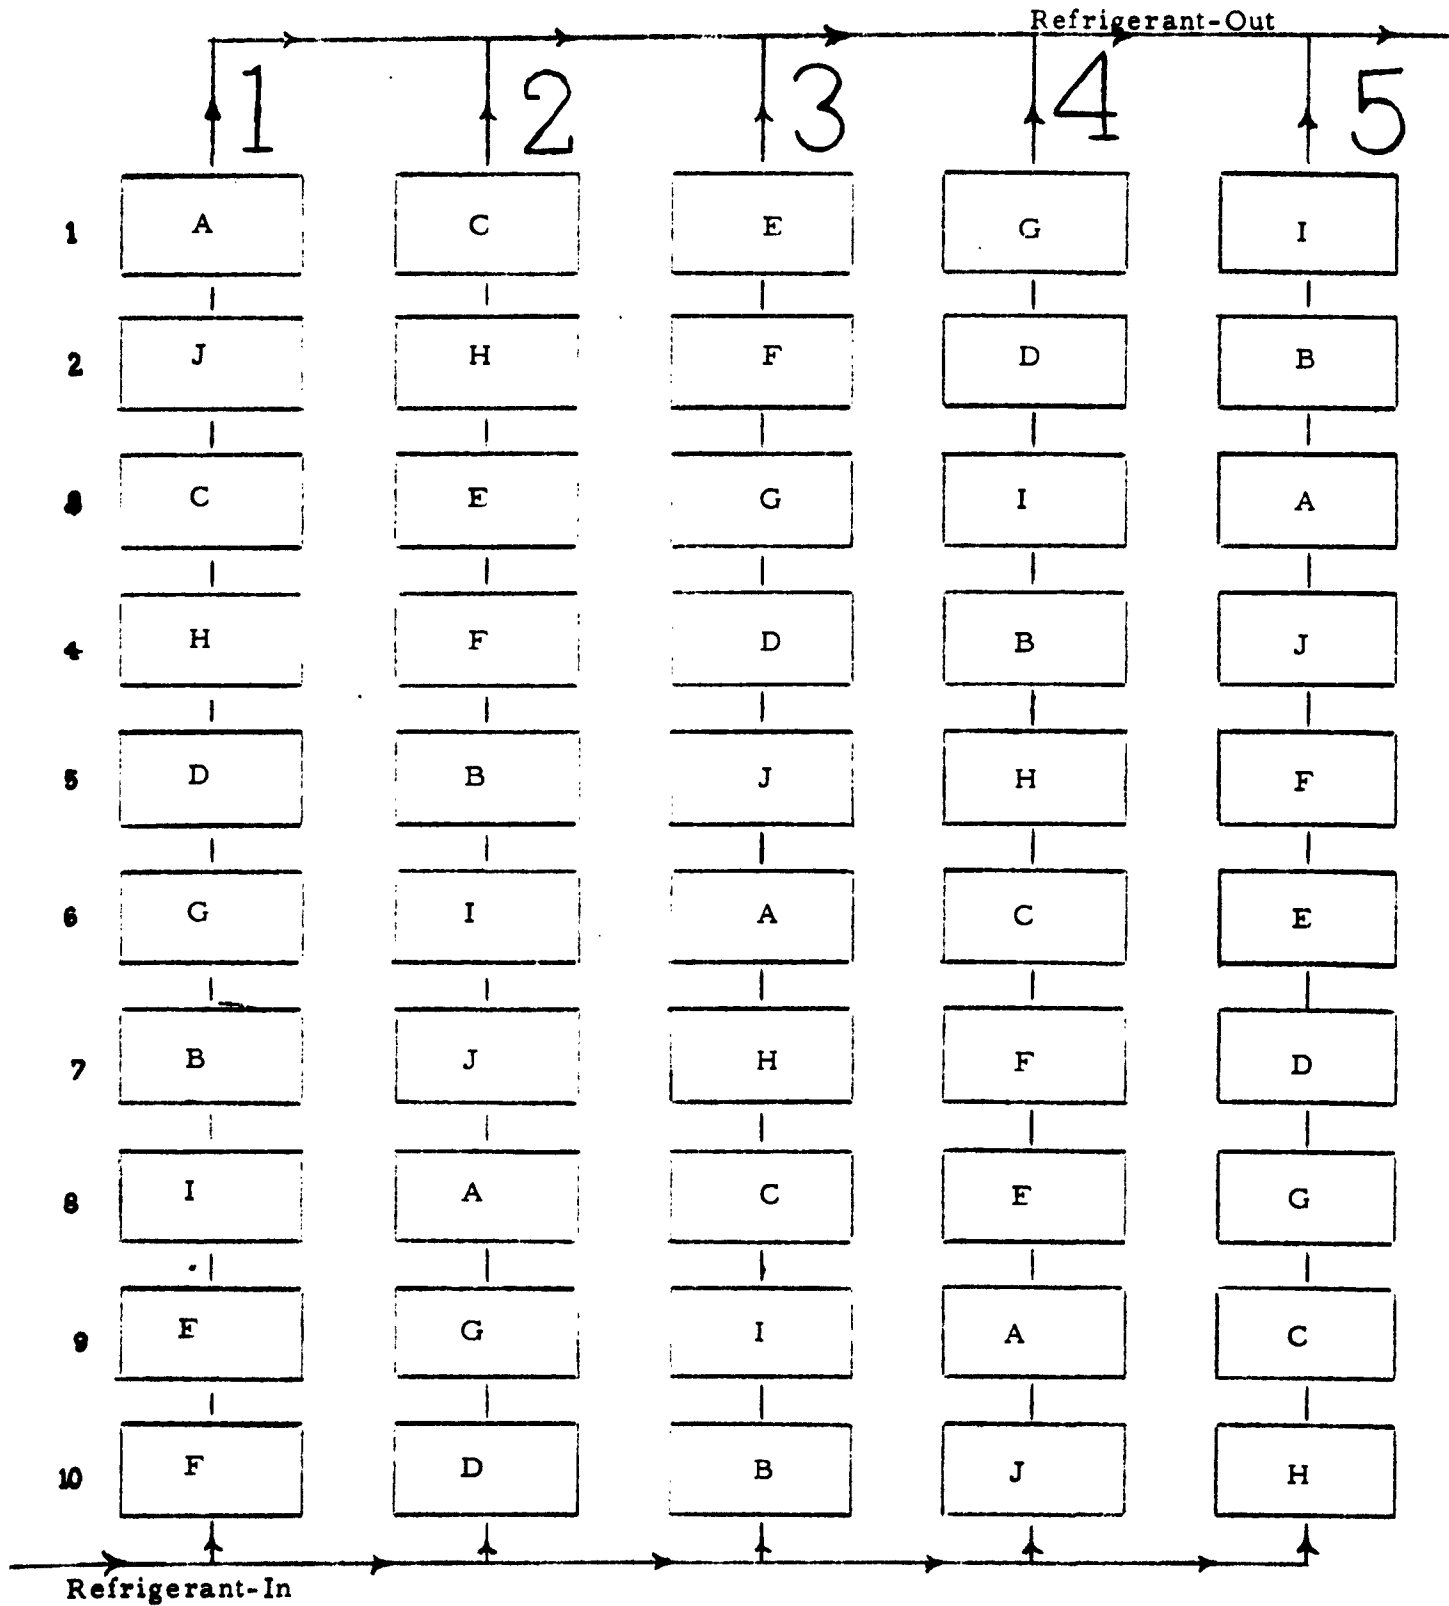
ARRANGEMENT OF PANELS IN TEST CABINET

Tables C and D list the amount of rusting occurring on each of the test coupons in this series of tests. The test coupons are identified by the number of the water jacket and space over which they were mounted. Plate 1 illustrates the relationships of the numbers.

In order that there should be no unwanted metal-to-metal contact, panels were mounted on the water trays between rubber gaskets. The rubber gaskets were fitted over threaded studs spaced along the rims of the mounting openings of the water jacket. The water jackets were filled with water so that the underside of each mounted panel would be in intimate contact with the water. The test panels were held in place by an aluminum plate of the same dimensions as the rubber gaskets which was held down with wing nuts.

During these tests it was noticed that water jackets #1 and #5 during Test #1, and water jackets #1, #2, and #5 during test #2 were not completely filled with water. The incomplete filling was due to leaks around connections and joints of these jackets which have since been repaired. However, during these tests, panels mounted over these water jackets had considerably shorter periods of condensation in the condensation-evaporation cycle than did panels mounted over water jackets which were completely filled. This resulted in generally less severe corrosion on the panels mounted over these water jackets than occurred on other test panels of the same material. Exceptions are panels of B and D in Test #1 mounted on water jacket #1, which illustrated slightly more severe corrosion than shown on panels mounted over water jackets #2, #3 and #4.
